(NASA-CR-134130) ENGINEERING REPORT.
PART 3: NASA LIGHTWEIGHT WHEEL AND
BRAKE SUB-SYSTEM. LIGHTWEIGHT BRAKE
DEVELOPMENT (Goodrich (B. F.) Co.) 85 p
HC \$6.25 CSCL 22B G3/31 N74-12506
Unclas
22835

ENGINEERING REPORT NO. 4239
NASA LIGHTWEIGHT WHEEL AND BRAKE
SUB-SYSTEM CONTRACT WITH
B. F. GOODRICH

PART III
LIGHTWEIGHT BRAKE DEVELOPMENT

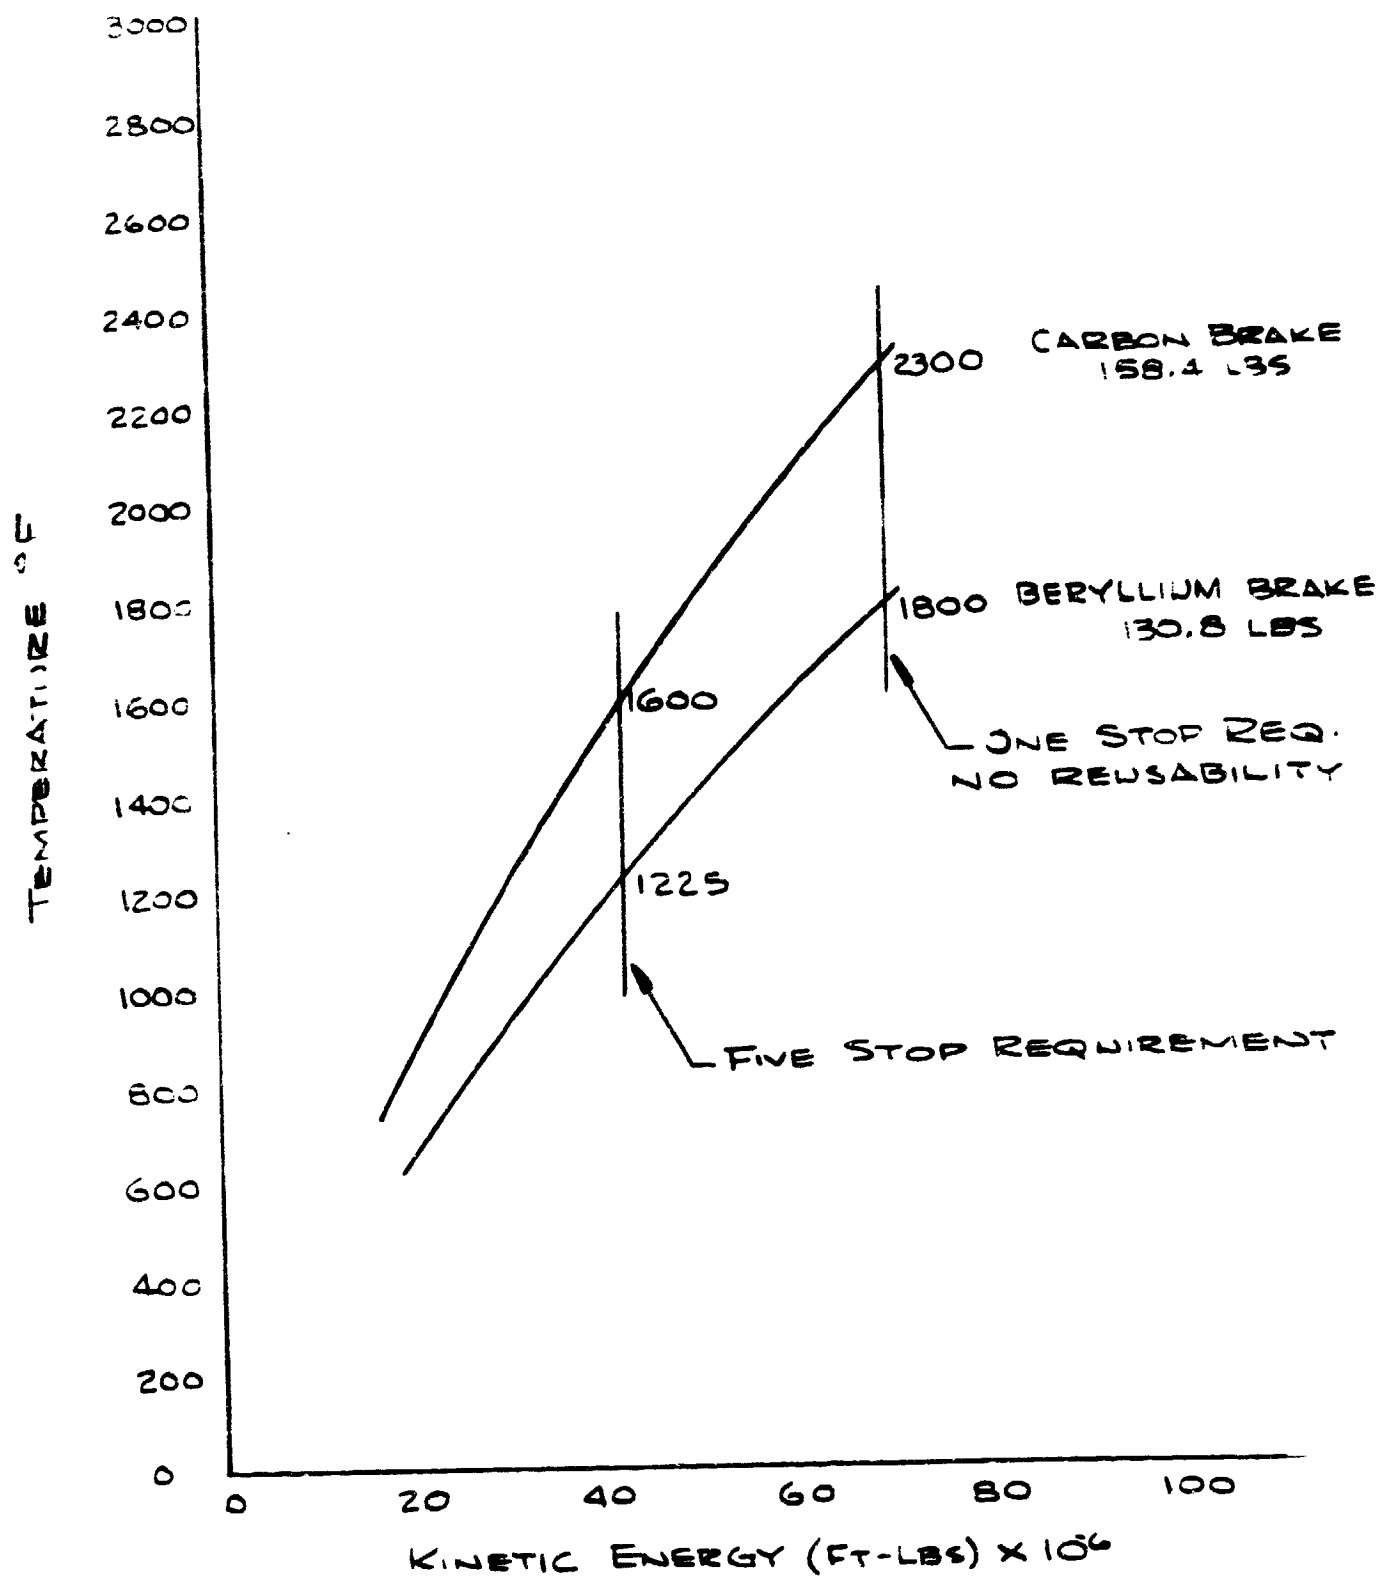
GRAPH NO. 2
HEAT SINK TEMPERATURE
VS
KINETIC ENERGY

The heat sink temperatures established for the brakes are shown on Graph No. 2. For the space shuttle requirement, the carbon lined beryllium brake saves 27.6 pounds per assembly and operates 400 to 500° cooler than the carbon brake. The wear rate for the carbon lining material, which was used on both brake designs, was .0002 / .0003 inches per surface per stop for the five stop requirement. The five stop condition would only require .0015 inches of lining per surface.

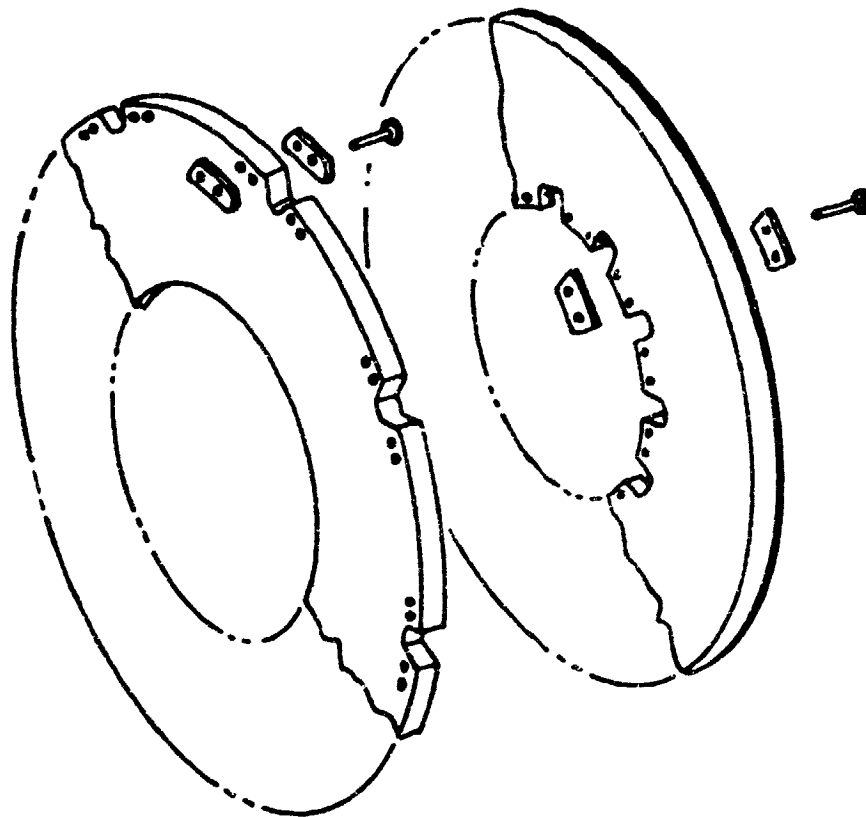
Figure 1
Structural Carbon Rotor and Stator Design

The structural carbon graphite composite heat sink is the industry's most recent development. Figure 1 shows a structural carbon rotor and stator. The design consists of disks with drives on the OD for the rotors and on the ID for the stators with steel reinforcement around each of the drive lugs. Its relative advantages and disadvantages are presented in Table III. It can be seen that carbon brakes have many positive features. The main disadvantage is that it must operate at extremely high temperatures for most applications to be weight-effective with the beryllium brake.

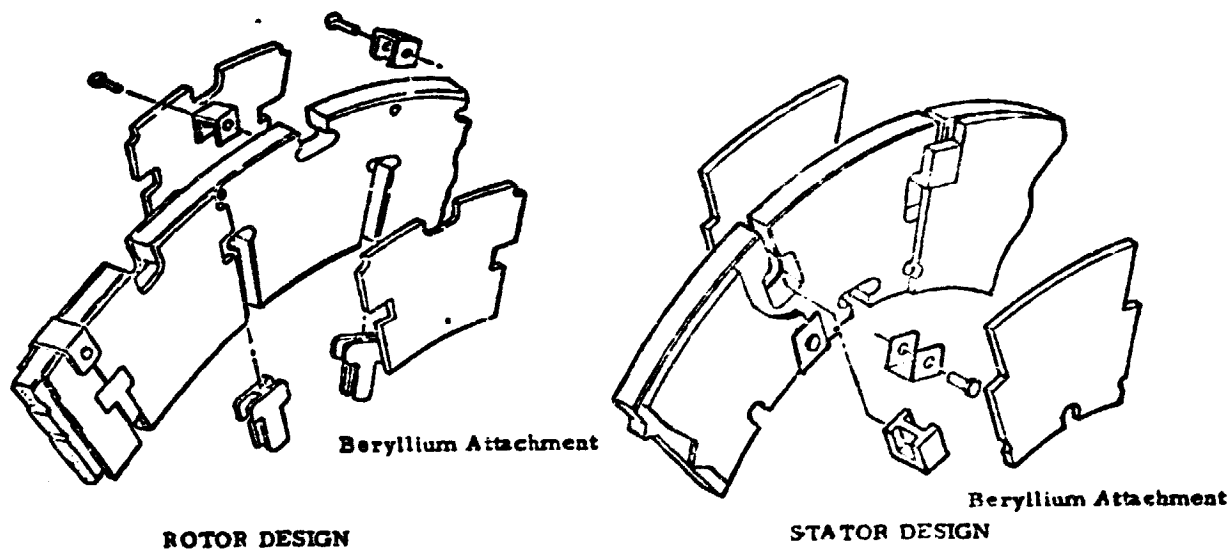
The beryllium heat sink has been proven in service on both the C-5A and F-14 aircrafts. Figure 2 shows the carbon-lined beryllium heat sink design, a derivative of the C-5 and F-14 basic design. This derivative uses carbon composites as lining rather than sintered iron with steel backing. The carbon-lined beryllium heat sink combines the frictional advantages of the structural carbon heat sink with the low operating temperatures of the beryllium heat sink. The advantages and disadvantages of the beryllium heat sink are listed on Table IV. The main advantage of using beryllium as a heat sink material is that for equal weight brake assemblies, the beryllium brake would operate cooler than the carbon brake.

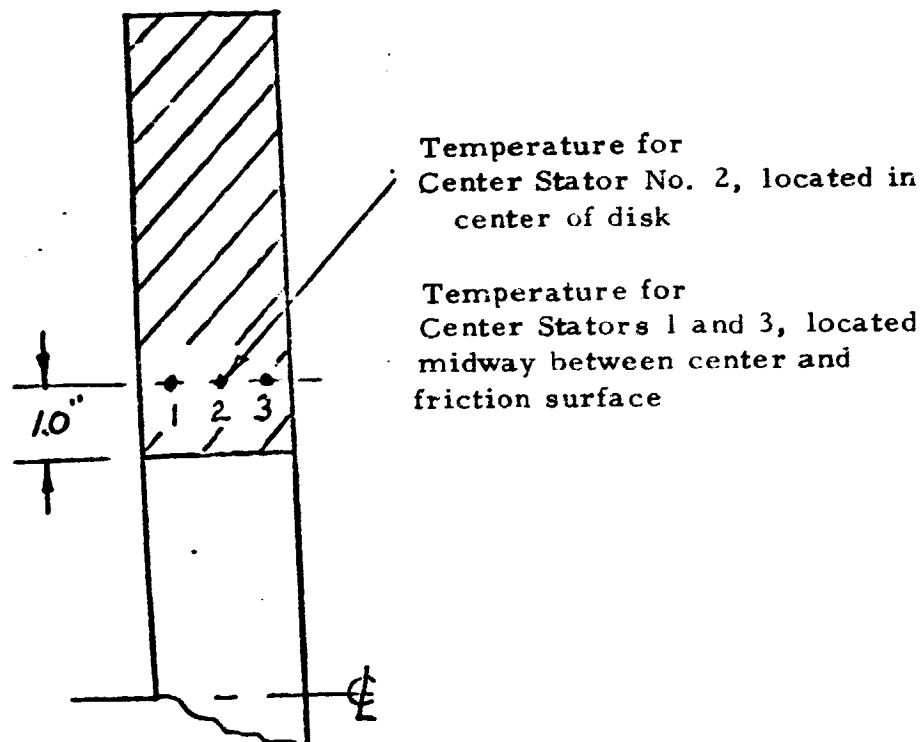
Center Stator
Fig. 5

Graph No. 4, page 14, shows torque and temperature versus stop time. The numbers 1 and 2 rotor temperatures (R-1, R-2) were measured on the outside diameter. The stator temperatures shown were measured at the inside diameter of the center stator as shown in Figure 5.

The stator thermocouples burned out at about $2,200^{\circ}\text{F}$. These thermocouples showed a temperature gradient of $4,700^{\circ}\text{F}/\text{In}$ in the beginning of the stop between Positions 1 and 2. The temperature gradient between the friction surfaces and thermocouples, Positions 1 and 3, is expected to be higher than $4,700^{\circ}\text{F}/\text{In}$.

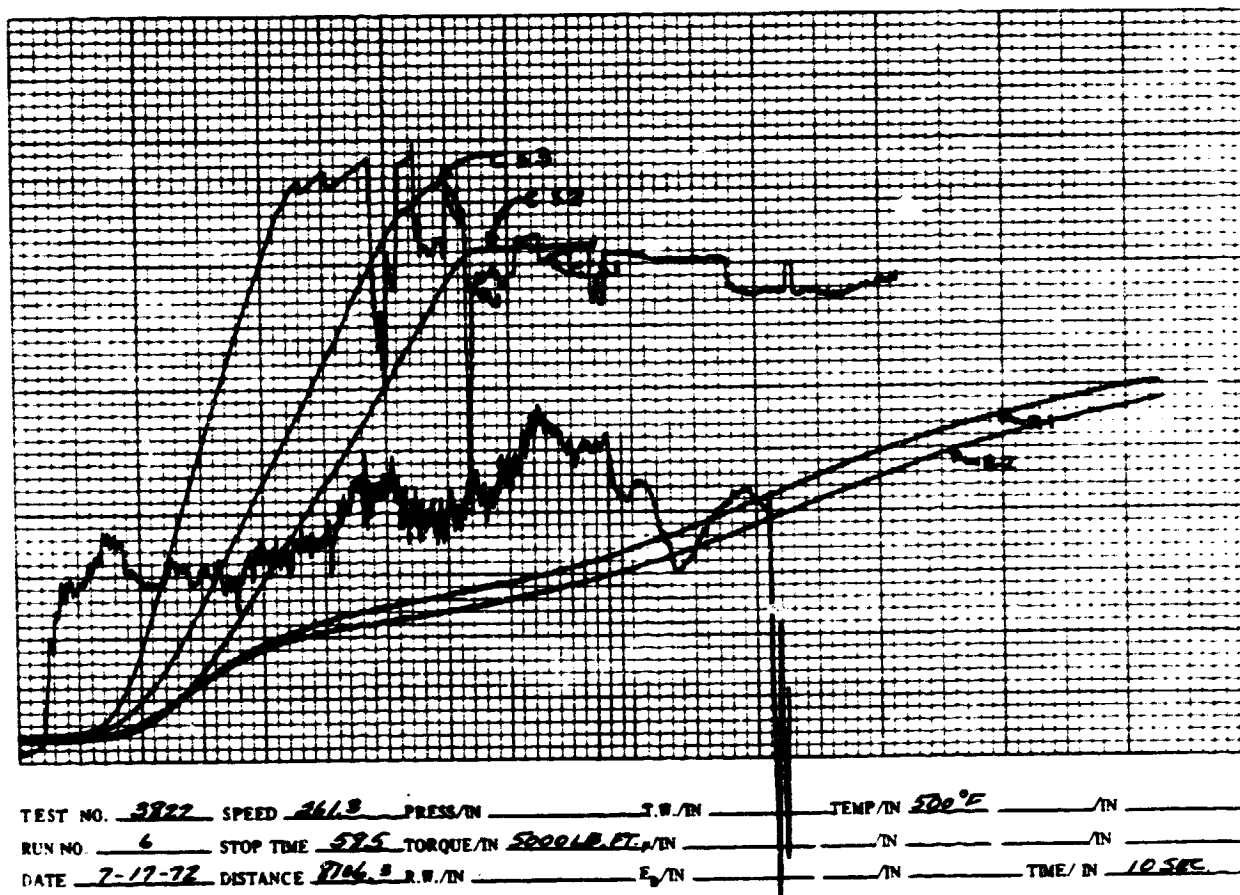
GRAPH NO. 4

PHASE I
TWO-ROTOR BRAKE TEST

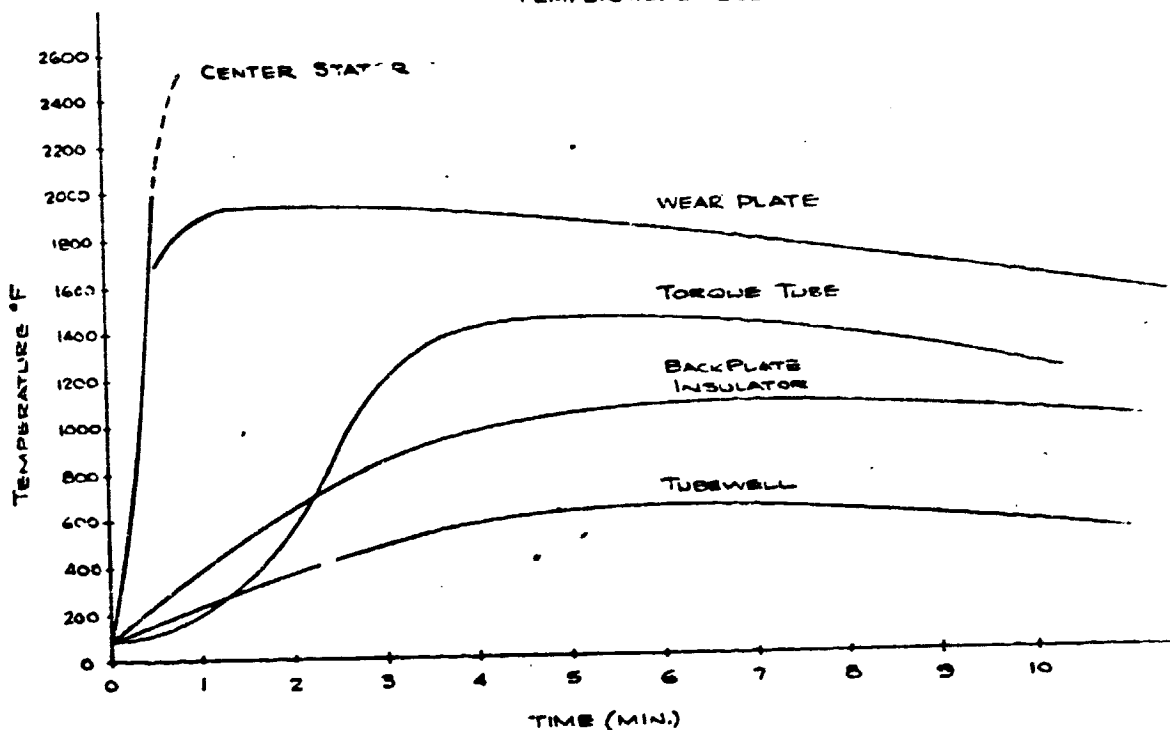
GRAPH NO 5 TEMPERATURE SURVEY TWO-ROTOR BRAKE TEST

PHASE I TWO ROTOR TEST
KE = 39.06×10^6 FT-LBS
HSL = 840,000 FT-LBS/LB
TEMPERATURE 2680°F

Danger exists in operating the maximum energy condition of 100×10^6 ft lbs at these temperatures in that without external cooling, the tubewell of the wheel could fail before the fuse plugs can deflate the tire.

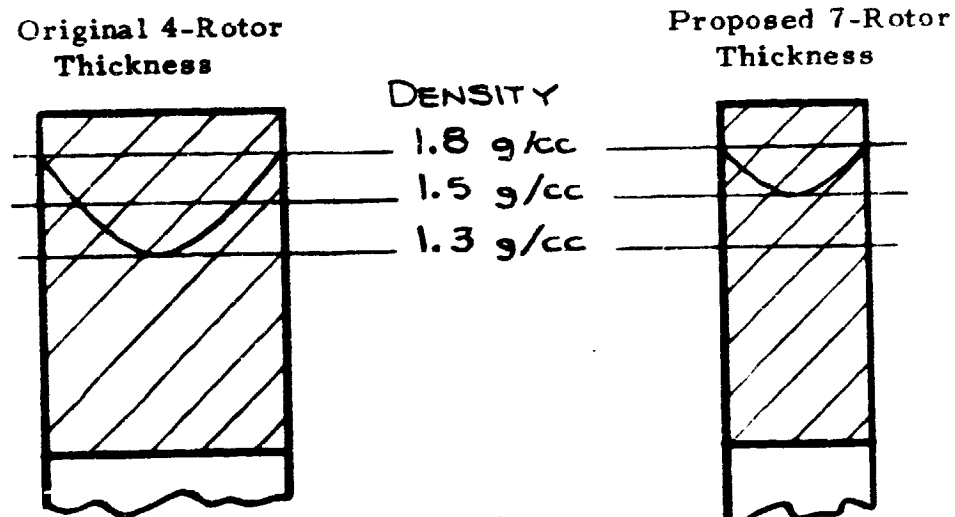
The problem with the thick parts is obtaining a high-density core. By reducing the thickness of the heat sink elements, the required penetration depth is decreased; increasing the density of the core. Figure 6 shows the relative improvement in density.

Increasing the density also improves the strength and thermal conductivity of the material; two important factors.

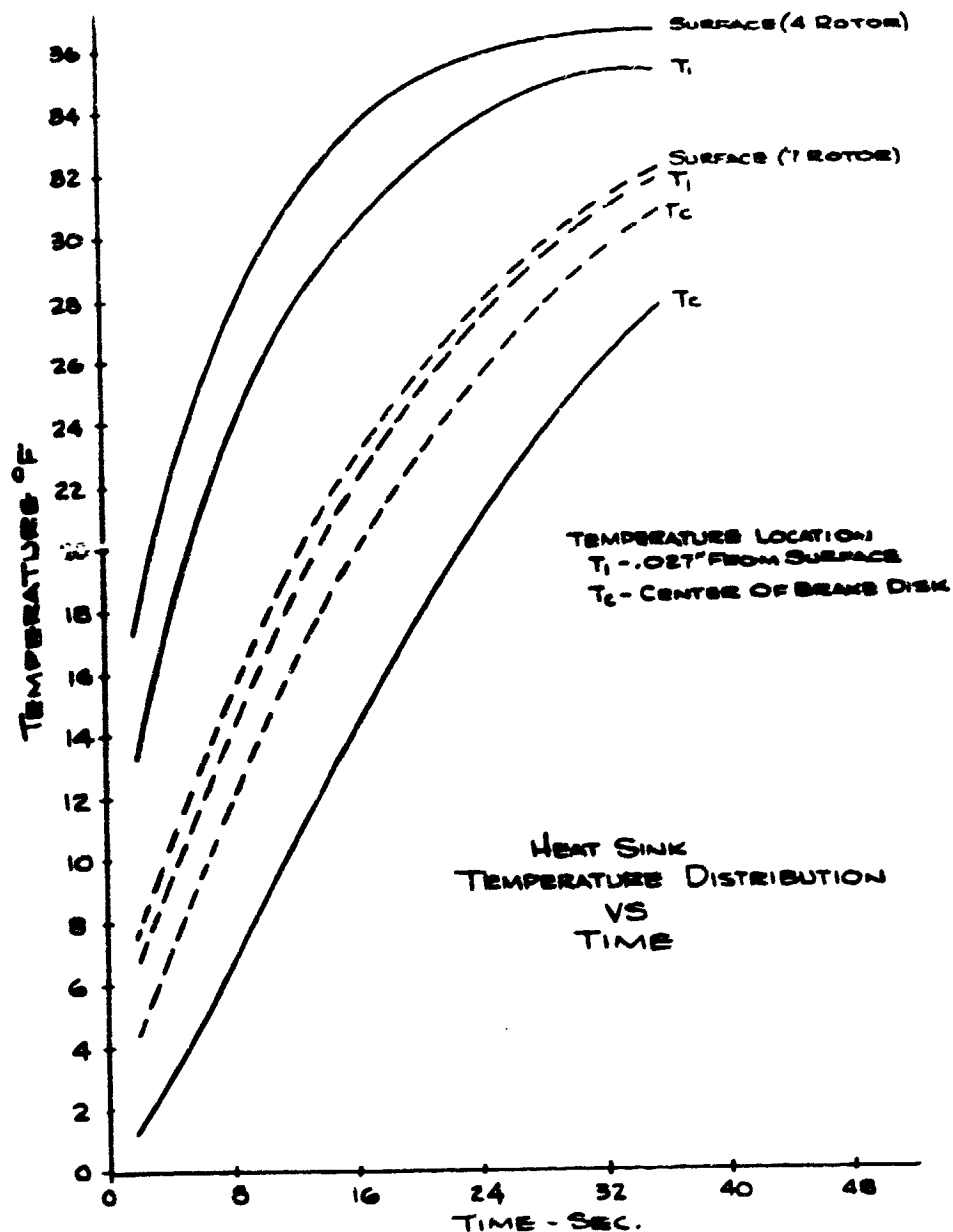
Graph No. 6 shows the comparison of the temperature gradients between the four and seven-rotor brake. The thermal stresses calculated for the seven-rotor brake were 2,570 psi compared to 11,900 psi for the four-rotor. This is a decrease in thermal stress of 78 percent.

GRAPH NO. 6
COMPARISON OF DISK TEMPERATURE
DISTRIBUTION BETWEEN A 4 & 7-ROTOR HEAT SINK

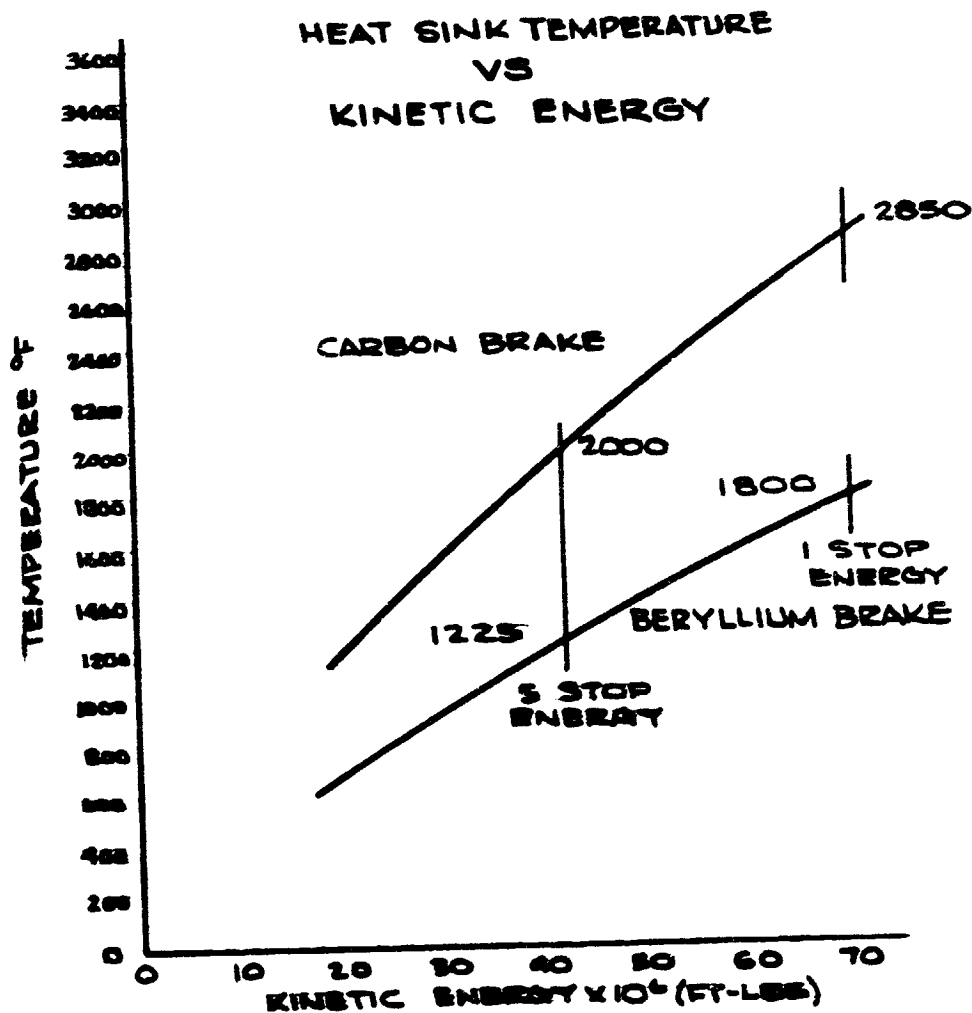
GRAPH NO. 7

Graph No. 7 shows the heat sink temperature vs kinetic energy, and Table VI shows the weight comparison for the brake designs in Figures 7 and 8.

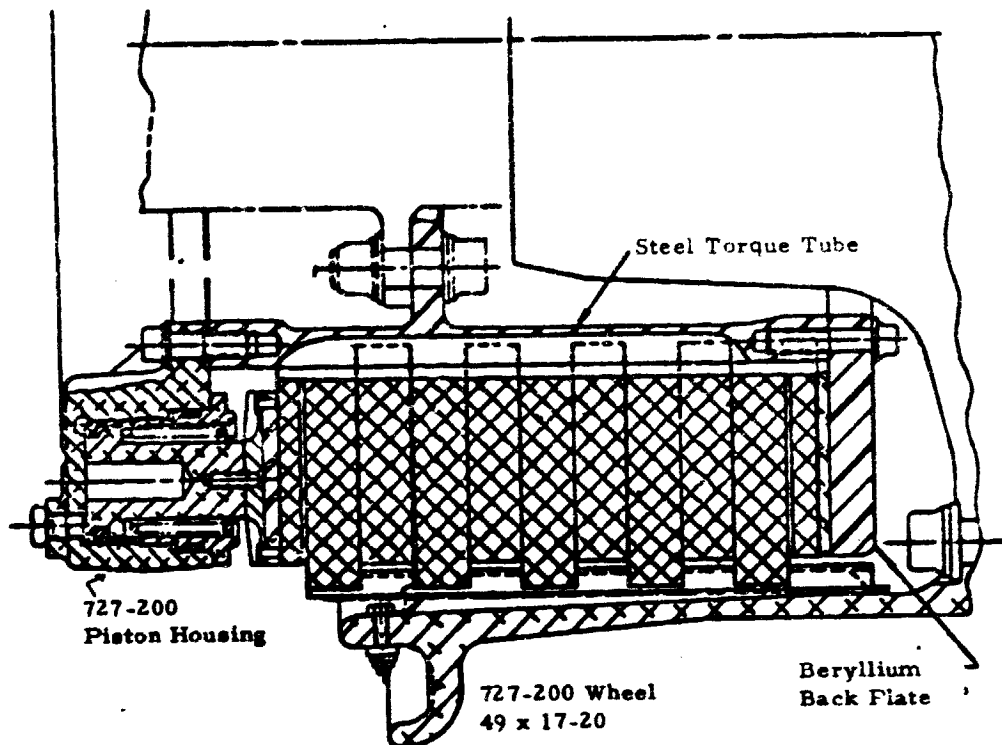
Figure 7

Structural Carbon/Graphite Heat Sink
P/N 2-1279-2

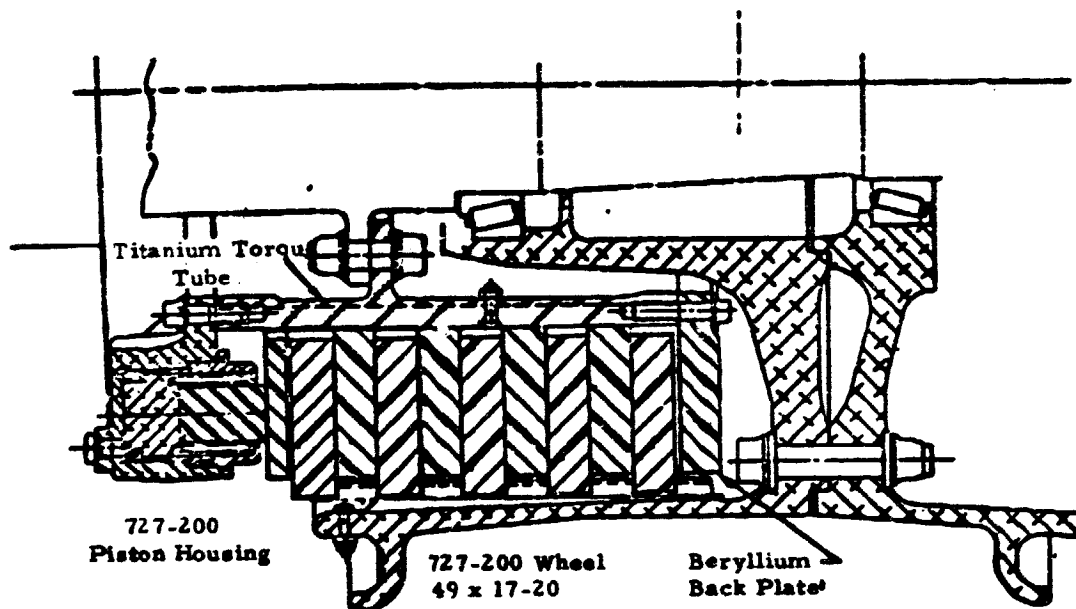
P/N 2-1279-3

Beryllium Heat Sink

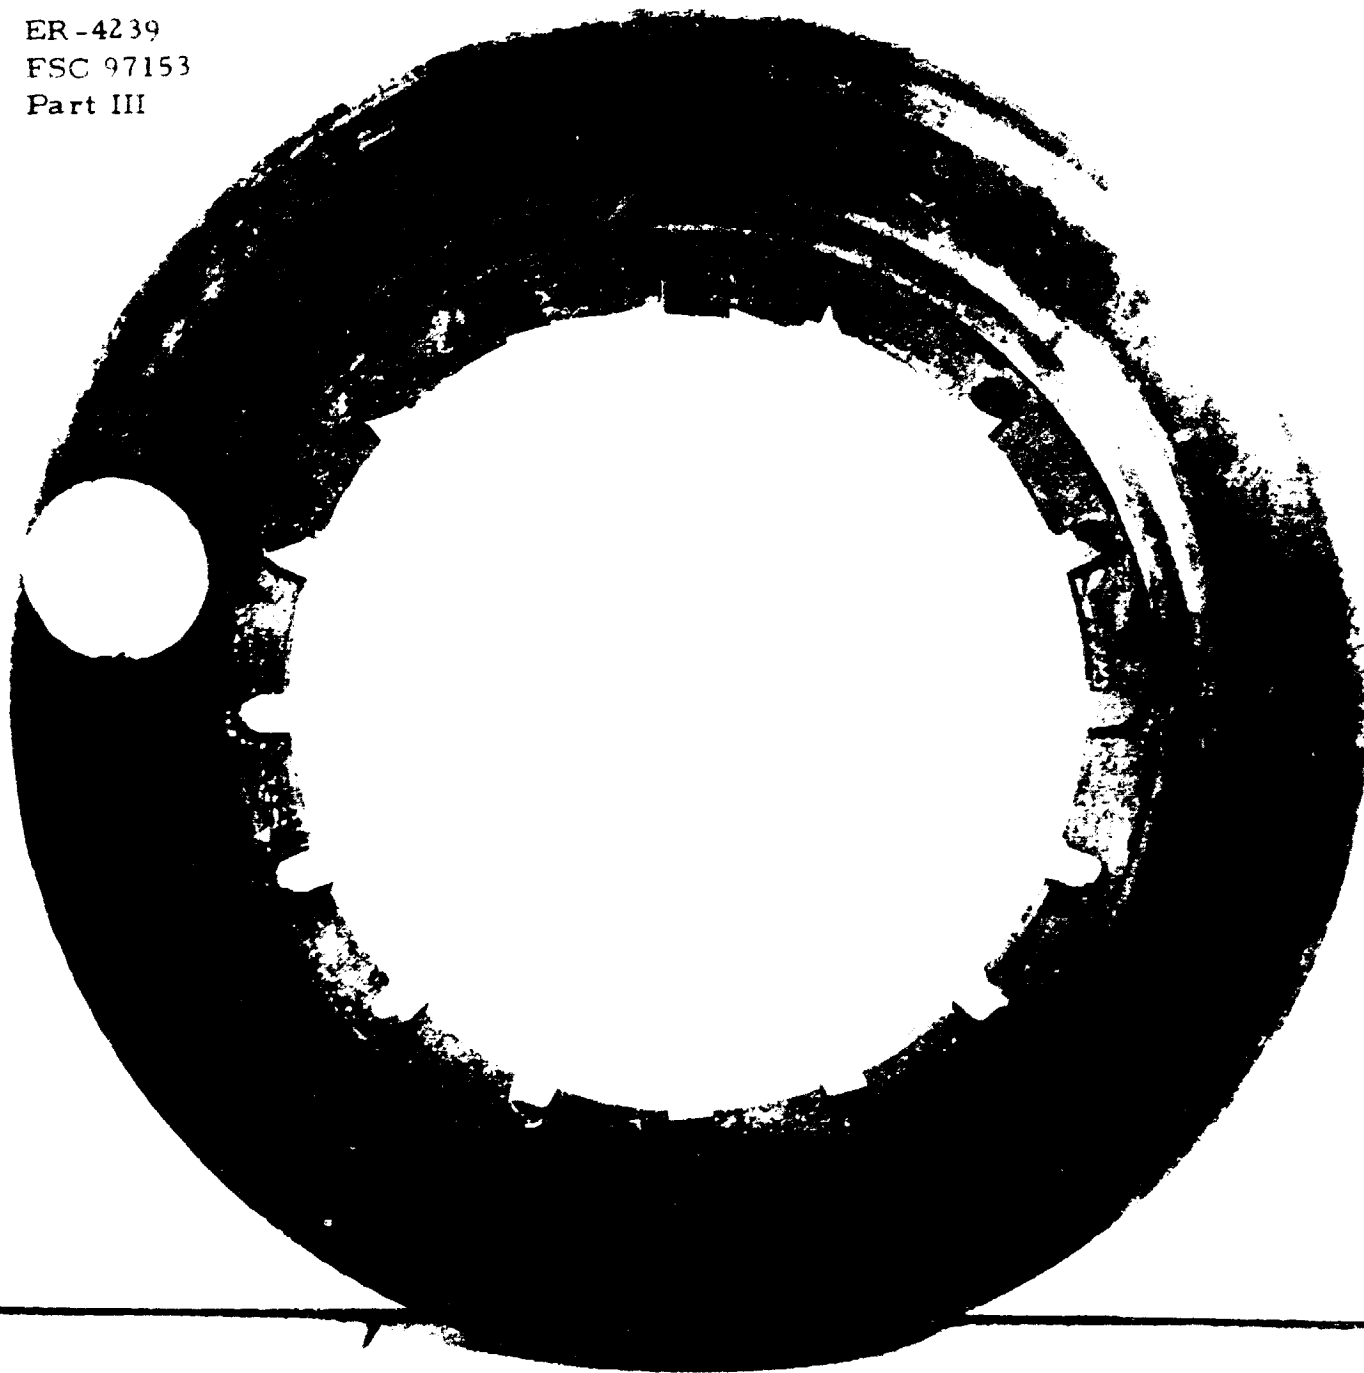
PHOTOGRAPH NO. 5

A crack was observed in the stator after the first normal stop, as shown by Photograph No. 5. The crack originated in the drive notch and was believed to be due to combination of mechanical and thermal stresses. The drive configuration was modified to reduce the stress concentration as shown by Photograph No. 6.

CENTER STATOR SHOWING CRACK IN DRIVE LUG AREA
AFTER THE FIRST NORMAL STOP

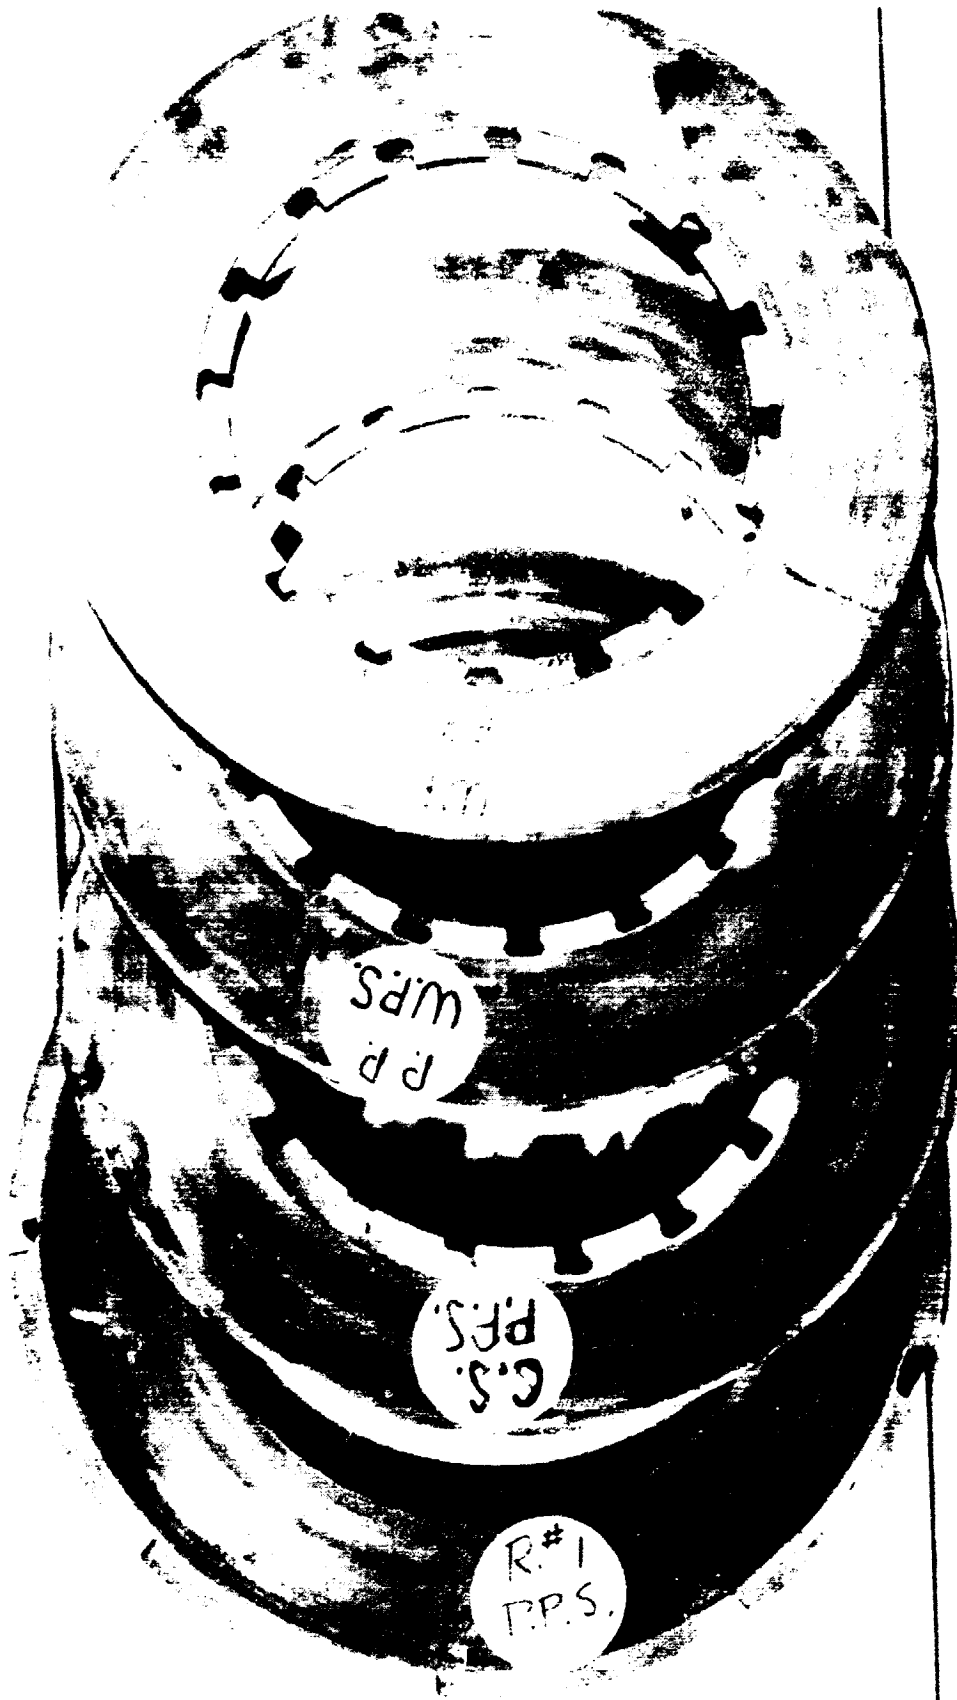
Five normal stops and one maximum stop were completed on the modified stator with no cracking. Cracks were observed in the rotors during the normal stops, but the tests were completed with no apparent problems. Photographs numbered 7 through 9 show the condition of the heat sink after testing.

PHOTOGRAPH NO. 7
HEAT SINK CONDITION AFTER TEST
to Normal Stops Maximum Energy Stop

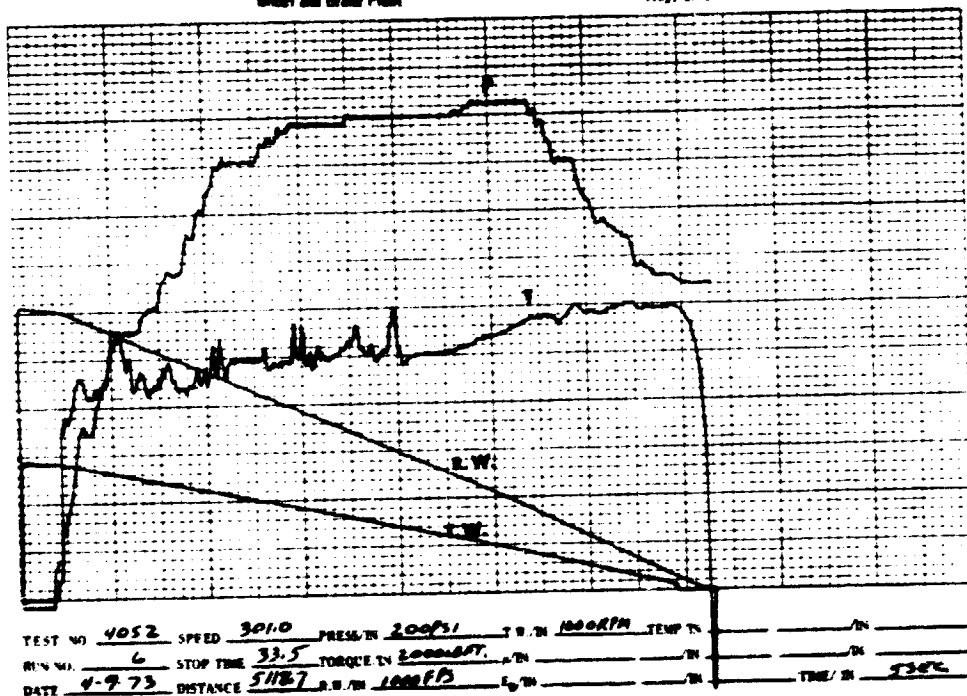
Graph No. 8
Pressure, Torque VS Stop Time -- Normal Energy

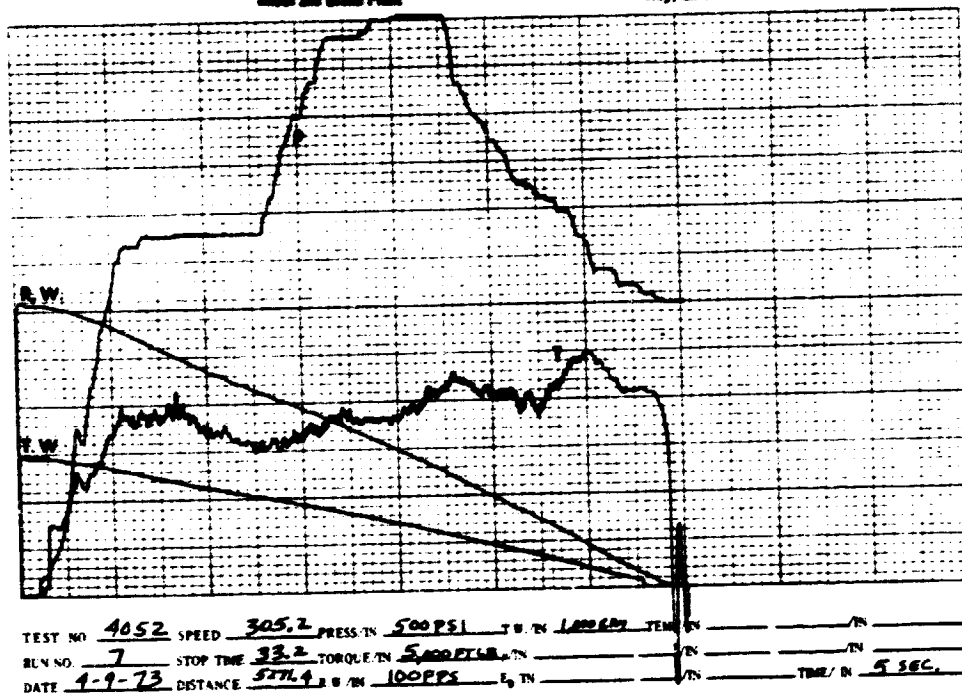
Graph No. 9
Pressure, Torque VS Stop Time -- Maximum Energy

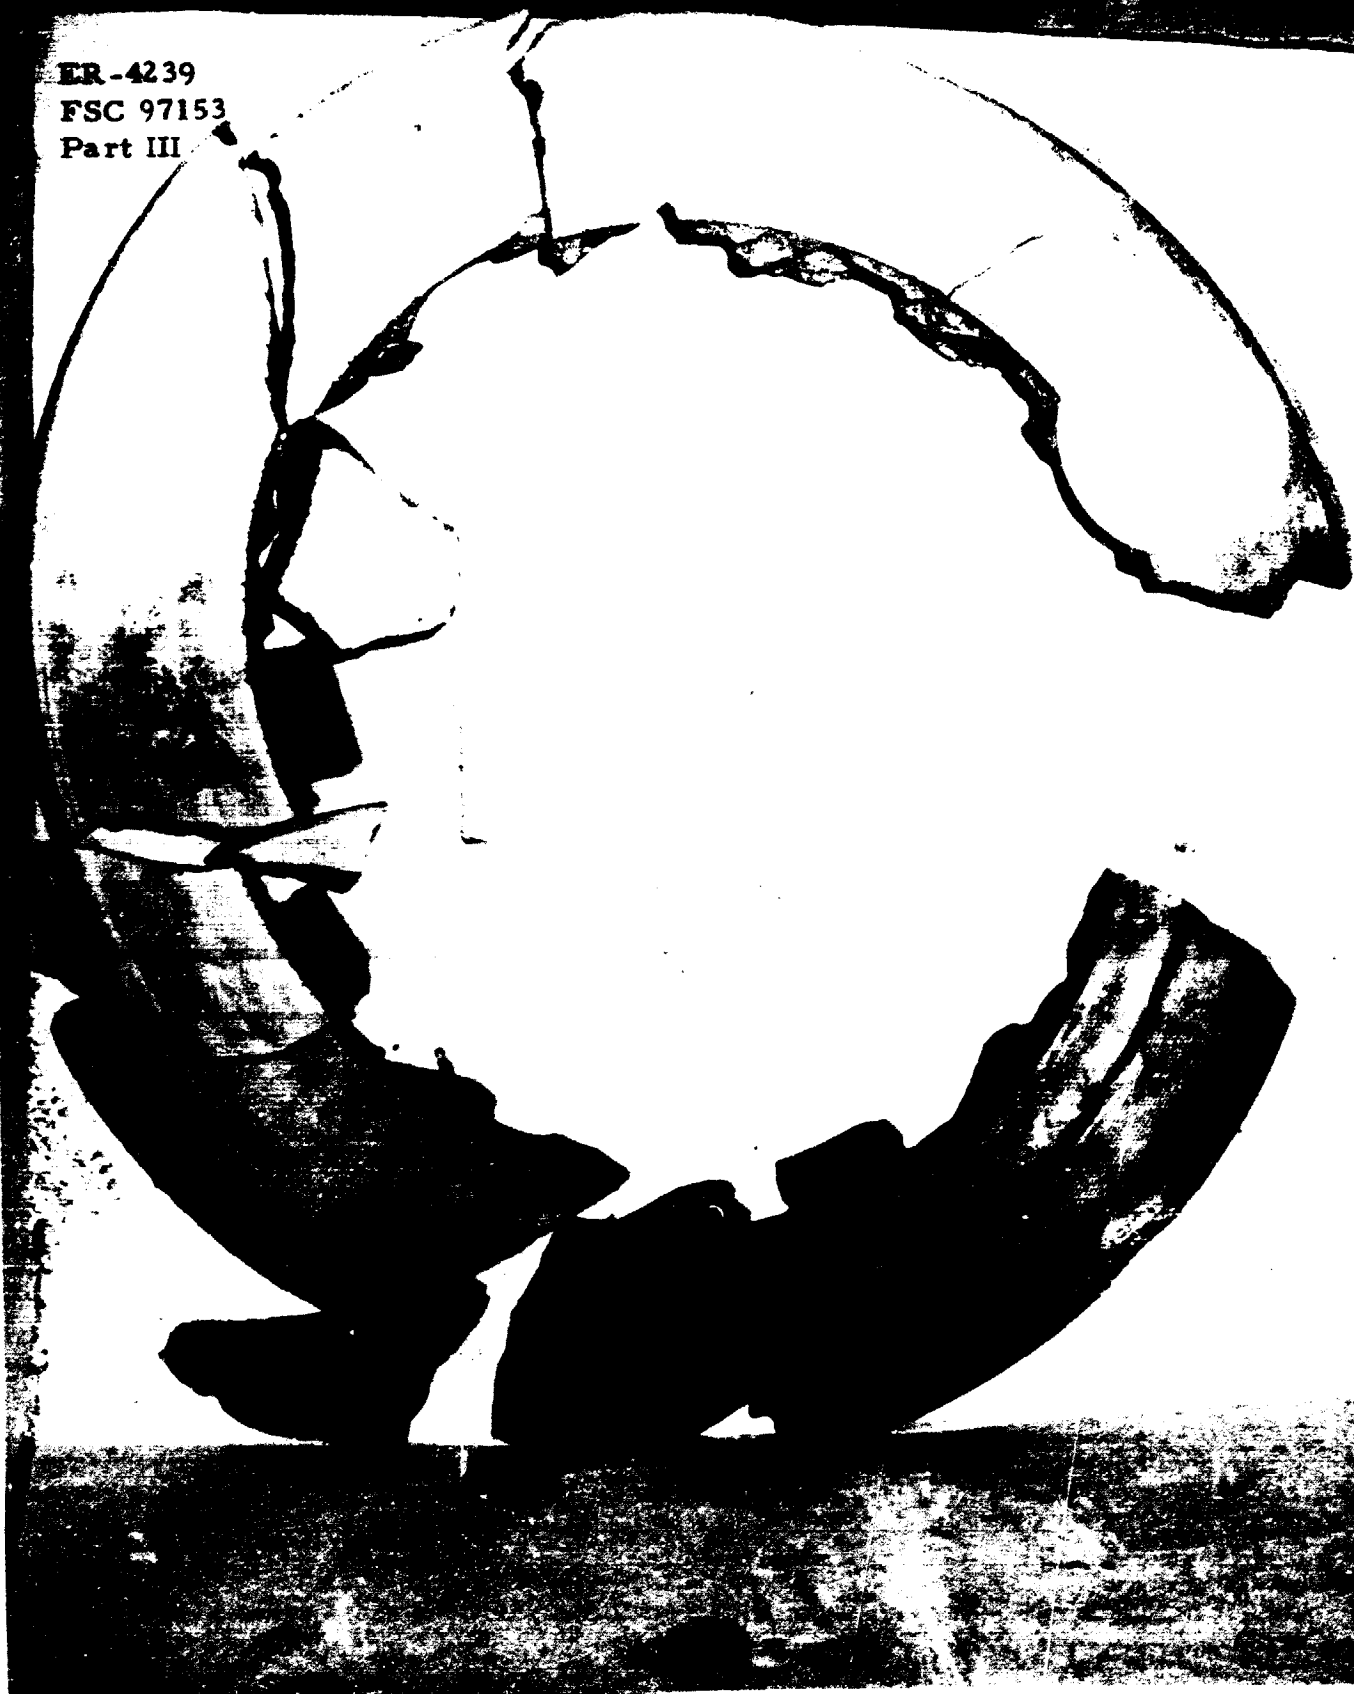
An attempt was made to test a full-size structural carbon brake to the space shuttle five-stop condition, operating at 2000°F and a one-stop condition, operating at 2850°F. During the initial testing, the No. 4 stator failed as shown by Photograph No. 10. Cause of the failure was believed due to a combination of mechanical and thermal stress and the unequal distribution of load throughout the heat sink. The thermal stress was believed to be the major cause of failure, as theoretical stress analysis showed that the mechanical loads on the stator were running approximately four percent of the ultimate strength of the material.¹ The wear of this material is very low, causing non-uniform contact across the face of this disk. The thermal conductivity of the material is low, and the localized contact areas caused hot bands producing high thermal stresses. Hot bands on the outside diameter of the stator put the inside diameter in tension which, with mechanical stresses, caused failure.

PHOTOGRAPH NO. 10
NO. 4 STATOR AFTER INITIAL TESTING

The No. 4 stator failed during initial Phase II testing of the full size carbon brake to the space shuttle 5-stop requirement.

This thermal stress, along with the mechanical loads, is believed to have caused failure.

**The analysis shows that the 1200^oF temperature gradient
is the major stress and is sufficient to cause failure.**

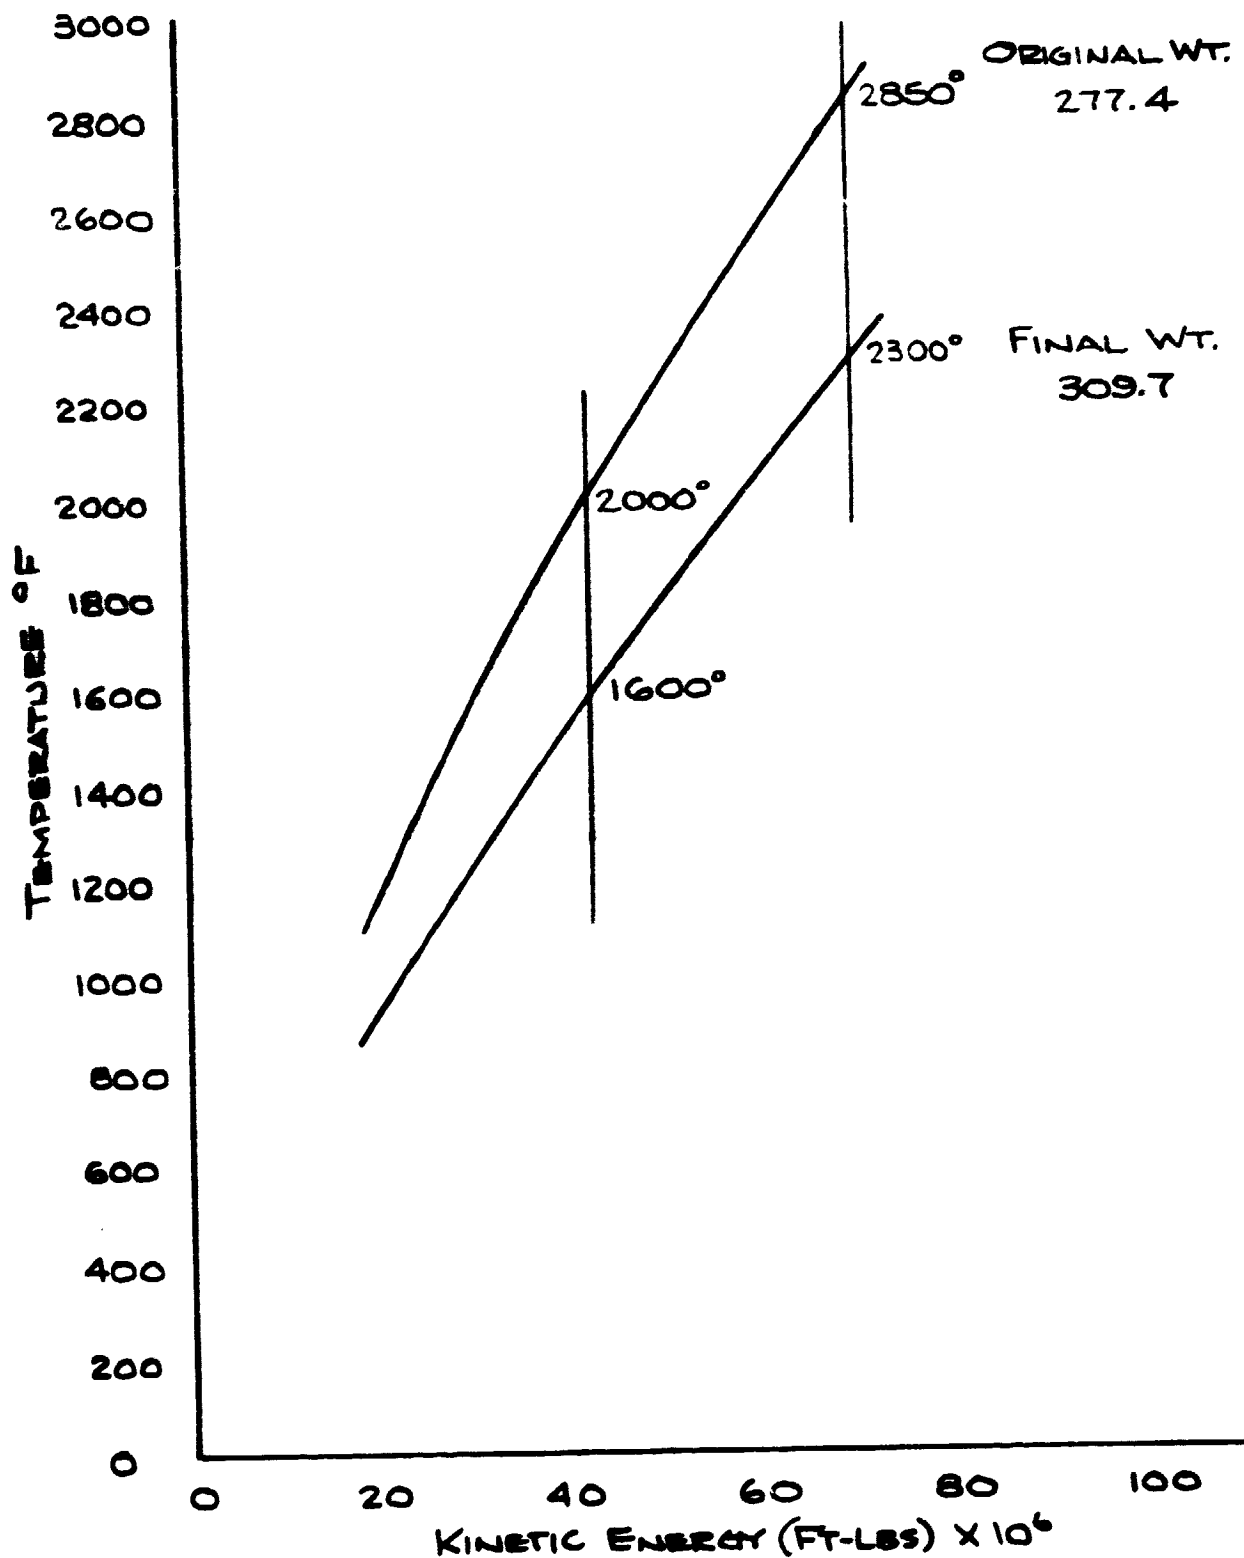
Graph No. 10 shows the comparison in the operation temperatures and weight between the original and final brake designs.

GRAPH NO. 10
CARBON BRAKE
HEAT SINK TEMPERATURE
VS
KINETIC ENERGY
